Subject: **Milwaukee County Fleet Garage – Condition Assessment Report
10320 W. Watertown Plank Road, Milwaukee, Wisconsin
ZS Project No.: 7523**

The following is a report of the ZS assessment of the main roof systems at the Milwaukee County Fleet Management maintenance and vehicle storage garage in Milwaukee, Wisconsin.

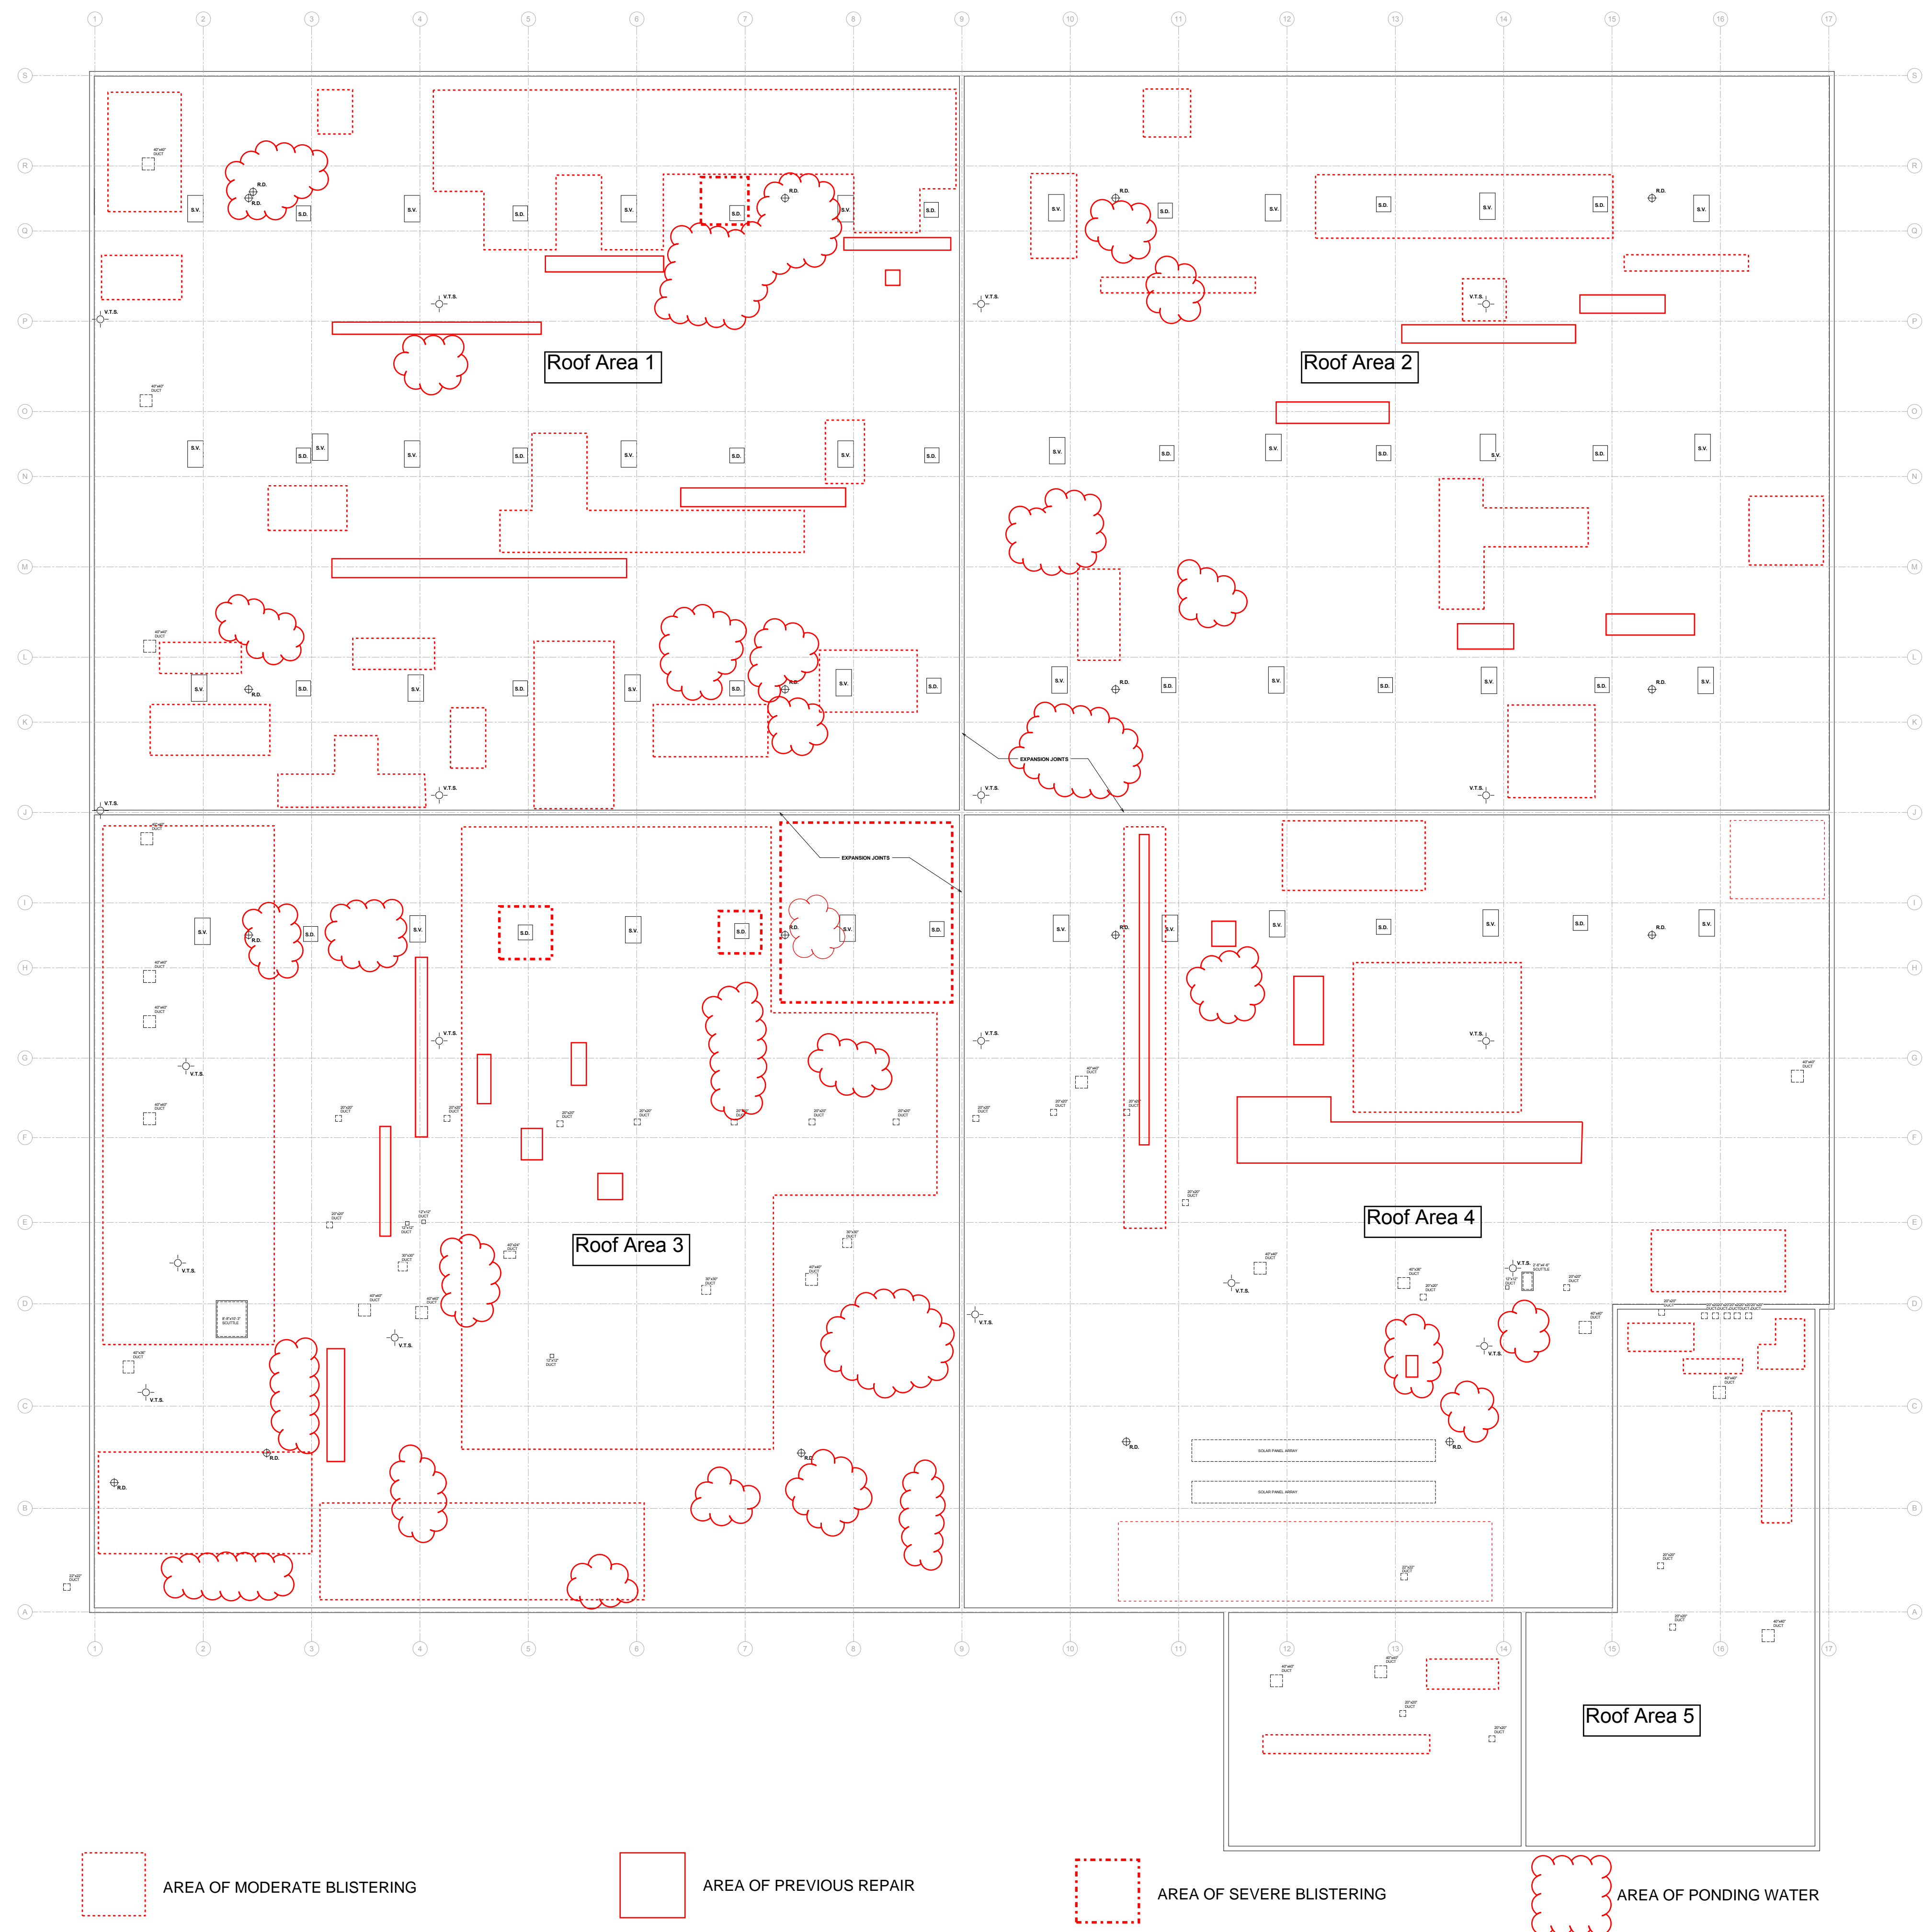
Appendix A-Roof Plan and Visual Observations

ZS was on site to make visual observations. A roof plan including identified defects is included in Appendix A.

ZS performed a visual survey of the main roof area and the lower roof area. In addition to the summary of observations noted below, Appendix A identifies the locations and types of observed deficiencies as recorded during our site observations. The following observations were made:

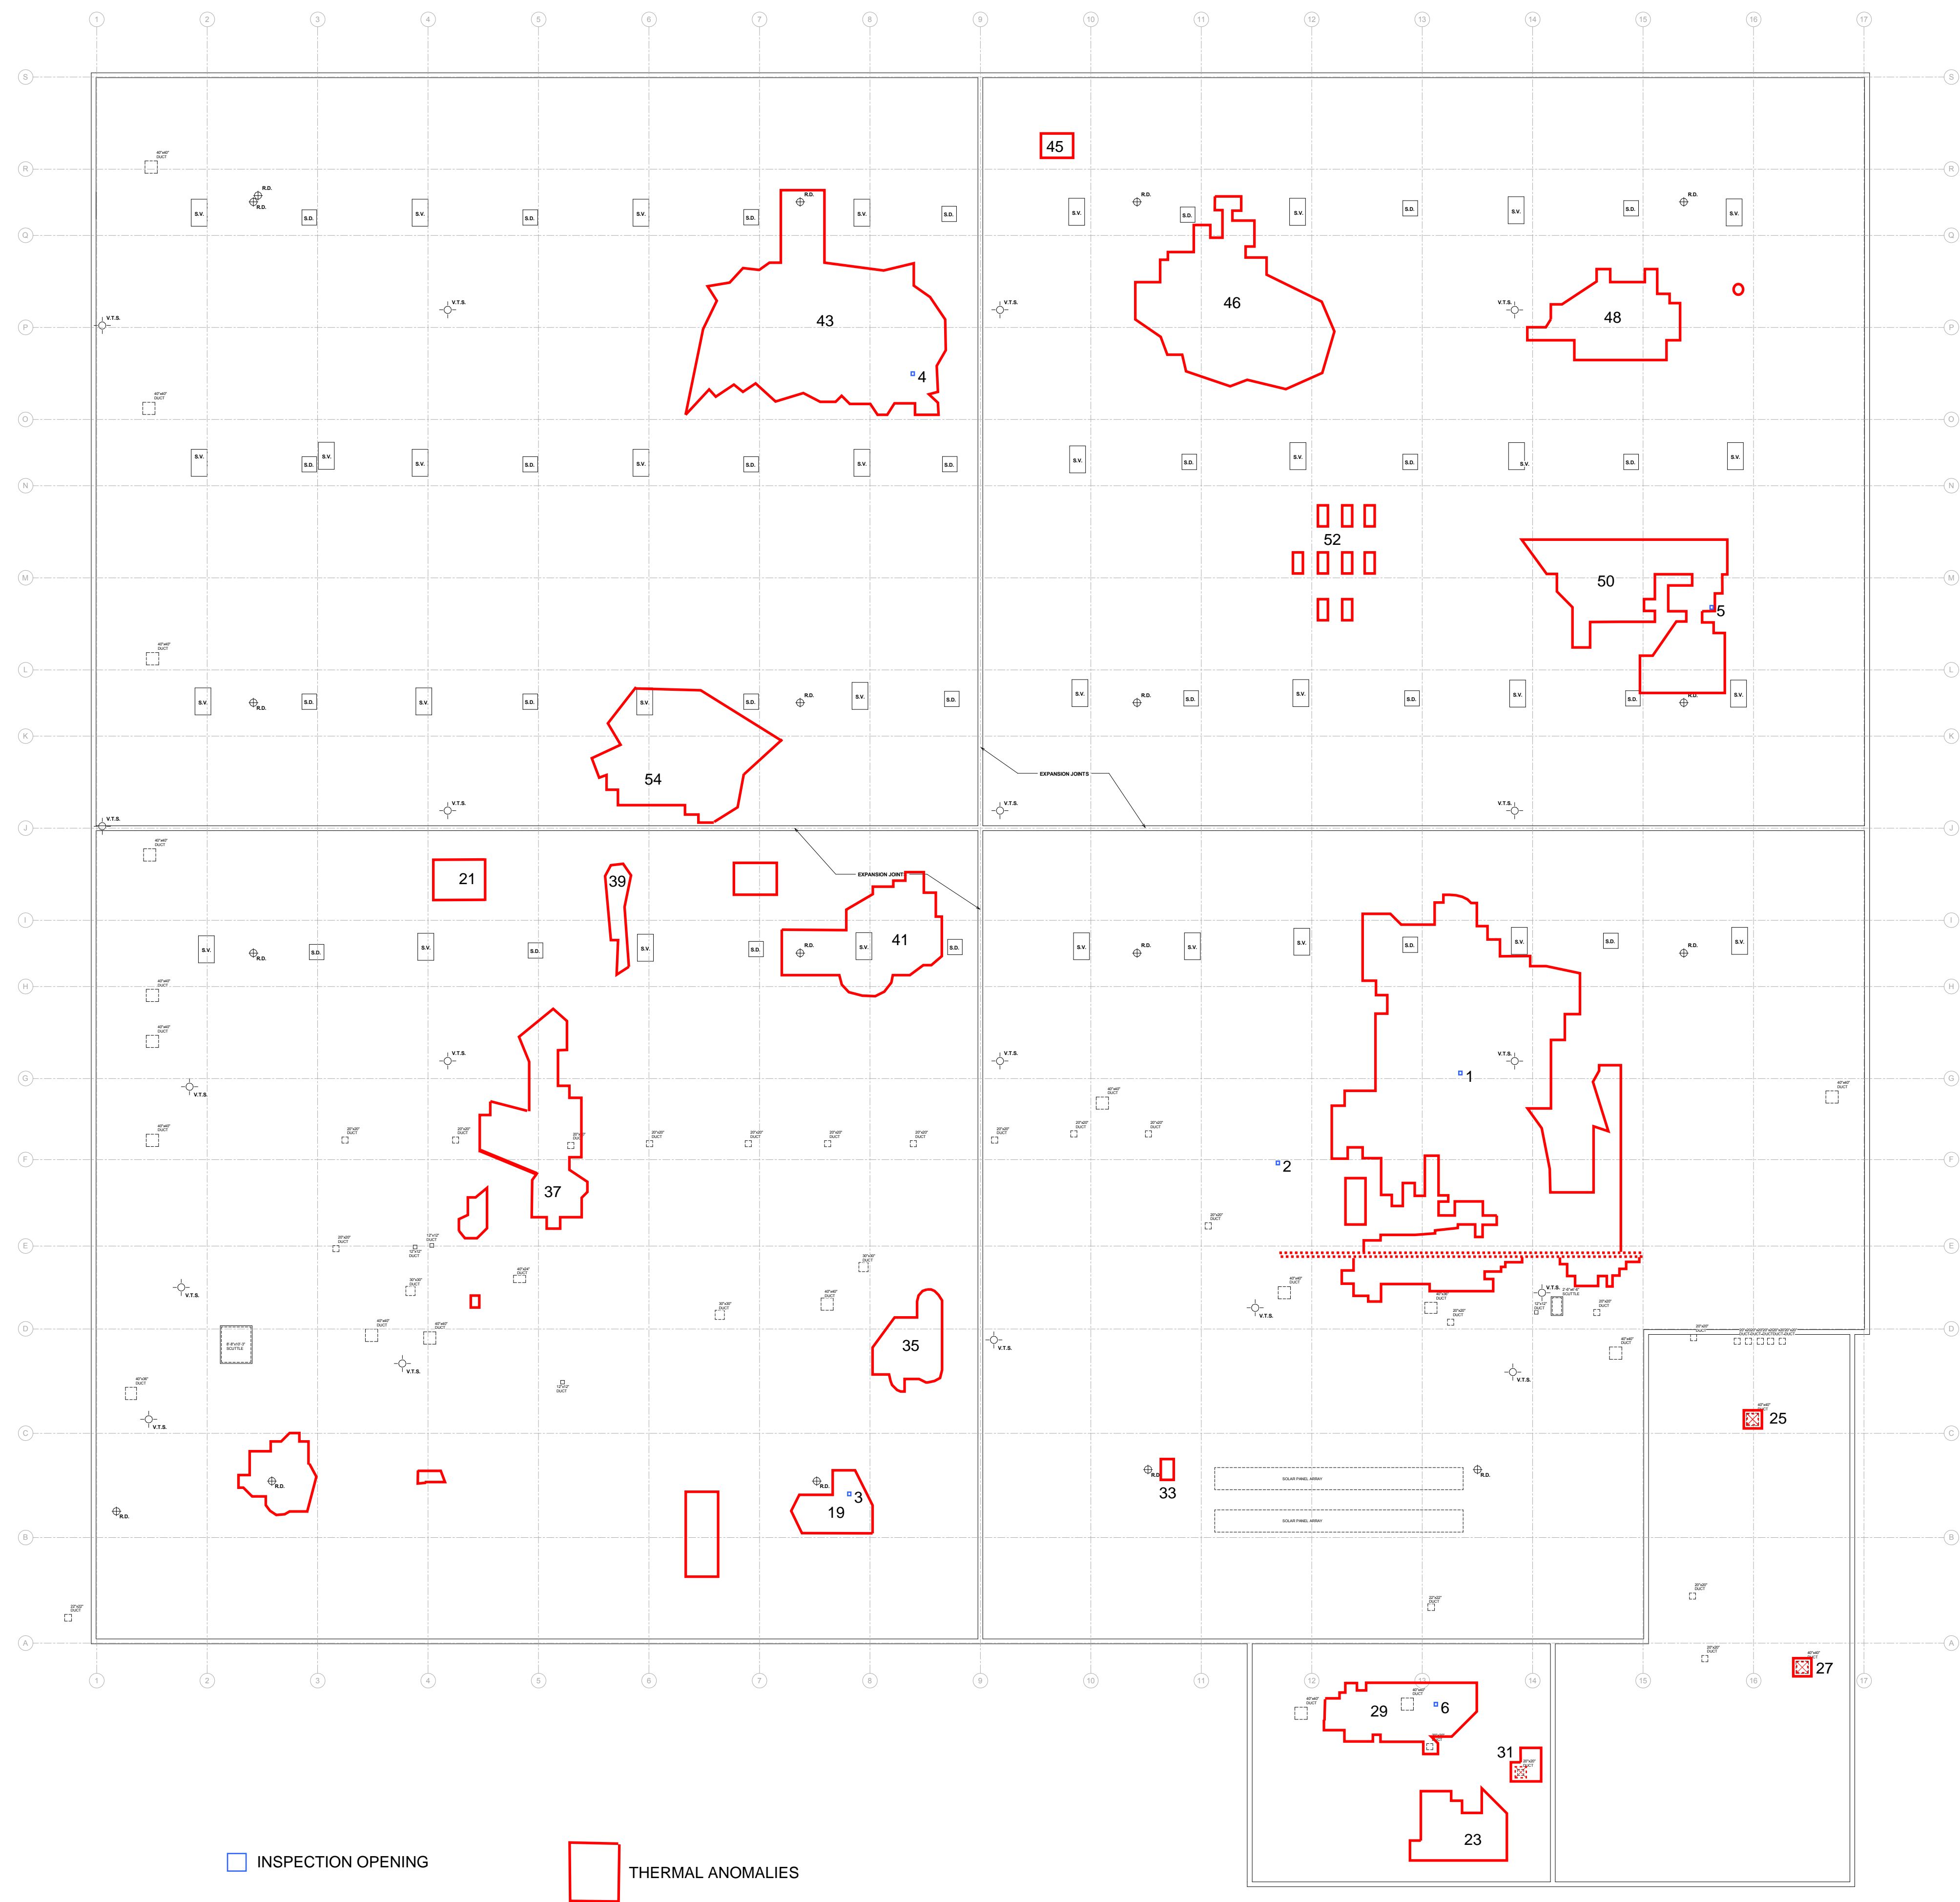
Appendix B-Roof Plan and IR Moisture Survey

- Thermal anomalies were observed at multiple locations in the field of the roof. Large areas of thermal anomalies were observed in various locations under various conditions, often but not always corresponding to areas of puddling water. See Appendix B for locations and photos (Figures 19-55) for the thermal anomalies.

ZS observed and documented roof inspections openings. The openings were created and patched by Langer Roofing and Sheet Metal, Inc. A total of (6) inspection openings at various locations throughout the field of the roof were made. These locations are shown in in Appendix B. A summary of the survey findings is as follows:
